# **INDOOR AIR QUALITY ASSESSMENT**

**Tatnuck Magnet Elementary School  
1083 Pleasant Street  
Worcester, Massachusetts**

Prepared by:  
Massachusetts Department of Public Health  
Bureau of Environmental Health Assessment  
June, 2001

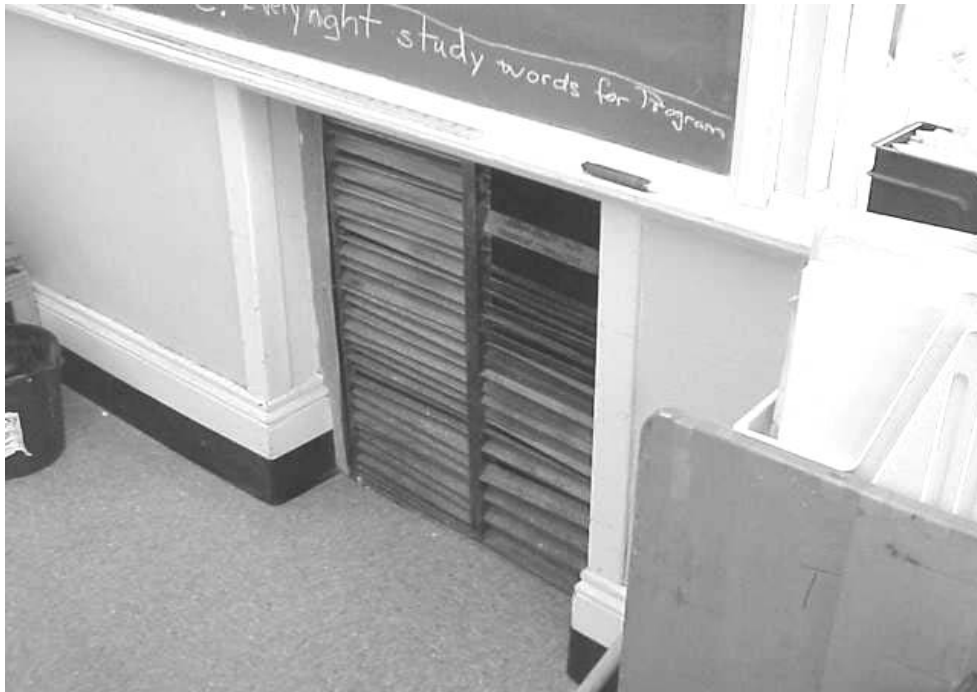
**Picture 1**

that creates ventilation in the same method as the fresh air supply system. Louvers to some exhaust vents were damaged (see Picture 1). Damaged louver fins can lead to difficulty in controlling airflow into the exhaust vent. Enhancing the draw of air up each exhaust vent is a revolving head roof ventilator (see Picture 2). The head of each vent is designed to rotate, with the fin keeping the opening facing away from wind, in a manner similar to a weather vane. The design of the vent creates negative pressure at the opening in windy conditions, which draws air up ductwork (Ulrey, H.F., 1966). The openings for each revolving head roof ventilator were not oriented in the same direction, which can indicate that some of the vent heads may not be freely rotating. Under certain wind direction, this condition can result in air being forced back down the duct, preventing these vents from exhausting odors.

**Damaged Louvers to Exhaust Vent**

3. Repair the pulley chain/louver door systems in vents to provide ventilation as designed. Repair the hinged-pulley system windows to provide fresh air to classrooms without univents. Consider restoration of the building's original floor vent system to improve air movement, which would consist of removal of plugs from cool air vents on first floor. Regulate airflow in these classrooms with the use of the gravity/natural ventilation system and windows to control for comfort.

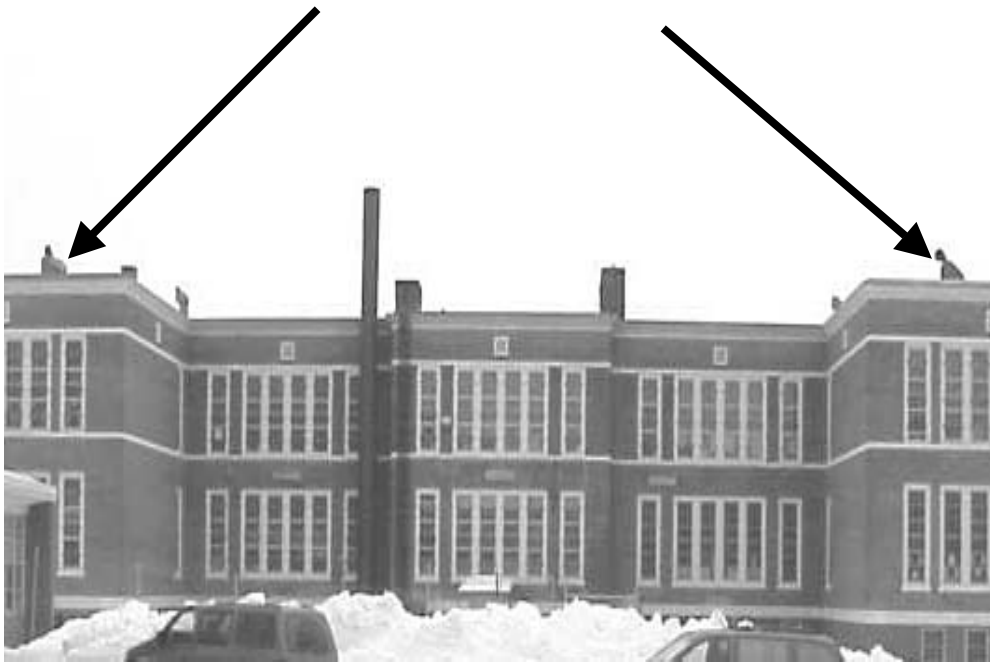
**Picture 2**

**Revolving Head Roof Ventilator, Note Unaligned Position In Wind**

1. Continue with plans to consult heating system consultants to improve heating and ventilation in the school.
2. Examine the ability of each revolving head roof ventilator for free rotation. Repair each vent as needed.

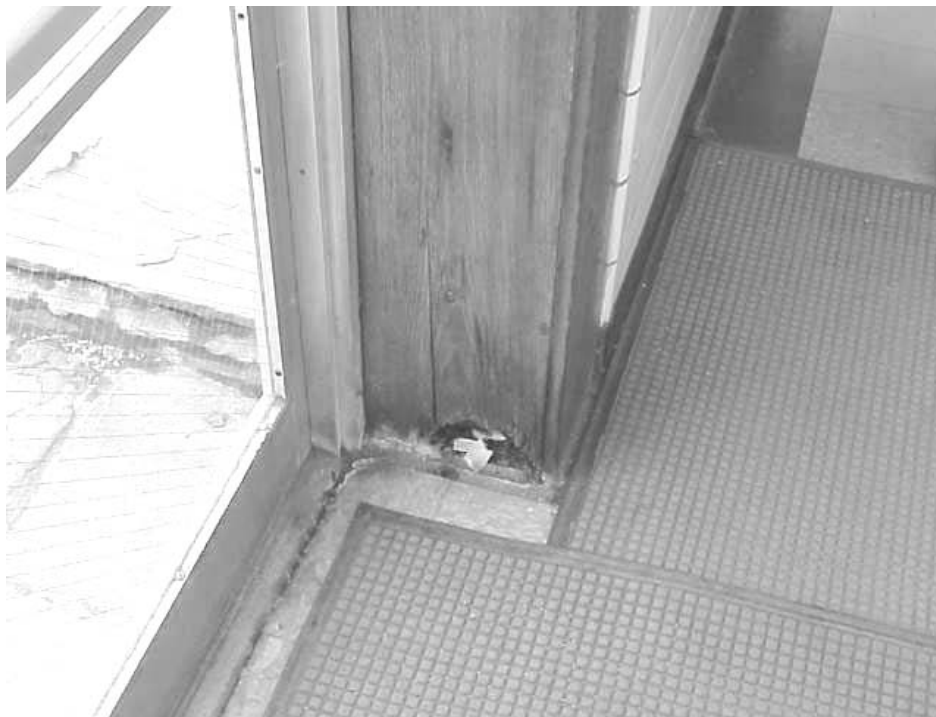
**Picture 3**

An exterior door in the hallway connecting the 1909 and 1954 wings have water damaged interior doorframes (see Picture 3). Repeated water penetration through the door threshold, wetting the doorframe wood, can create rot and mold contamination.

**Water Damaged Door Frame Wood**

13. Remove water damaged wood from hallway doorframe in Picture 3.
14. Replace missing ceiling tiles.

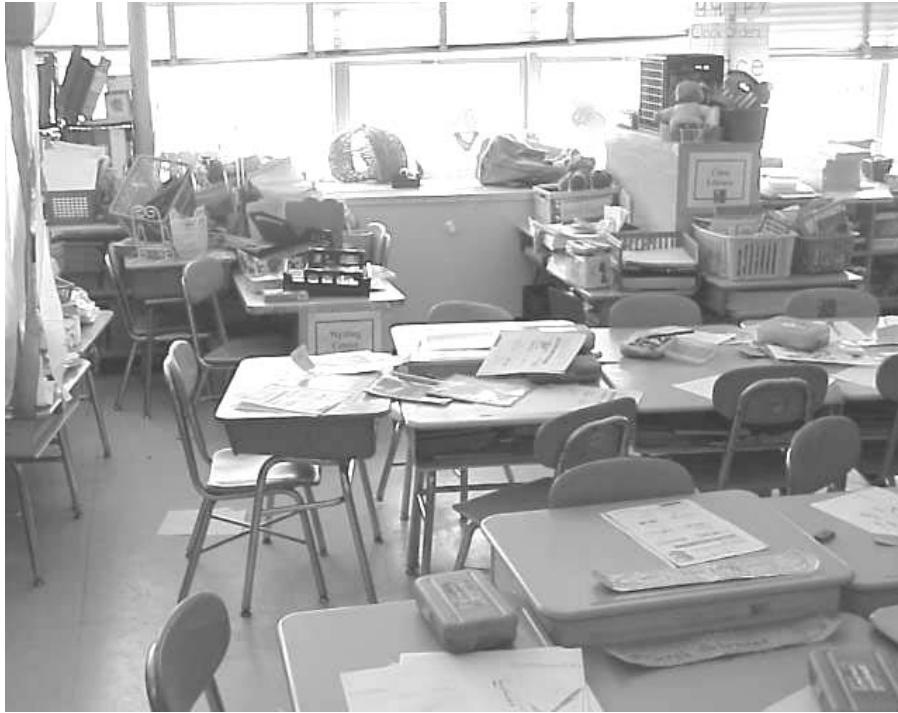
**Picture 4**

Also of note was the amount of materials stored inside classrooms (see Picture 4). In classrooms throughout the school, items were seen piled on windowsills, tabletops, counters, bookcases and desks. The large number of items stored in classrooms provides a source for dusts to accumulate. These items (e.g., papers, folders, boxes) make it difficult for custodial staff to clean. Dust can be irritating to eyes, nose and respiratory tract. Items should be relocated and/or be cleaned periodically to avoid excessive dust build up.

**Large Amount of Stored Materials in Classroom, Rendering Surfaces Difficult to Clean**

15. Relocate or consider reducing the amount of materials stored in classrooms to allow for more thorough cleaning. Clean items regularly with a wet cloth or sponge to prevent excessive dust build-up.
